DID L.C.C. KILL OFF THE STUD?

by John R. Prentice

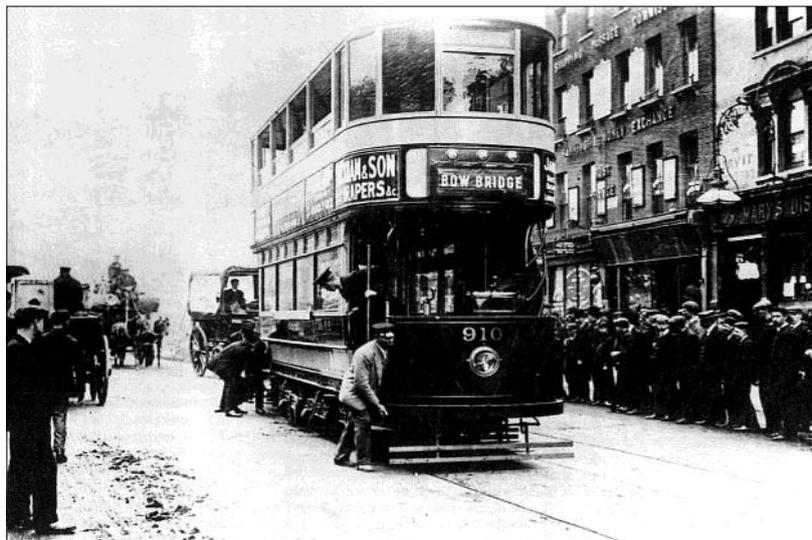
The interested crowds watch a stuck L.C.C. E/1 910 being manually pushed onto the next live stud in July 1908 during the ill fated trial. Note also the typically large amount of muck in the road to the bottom left of the view.

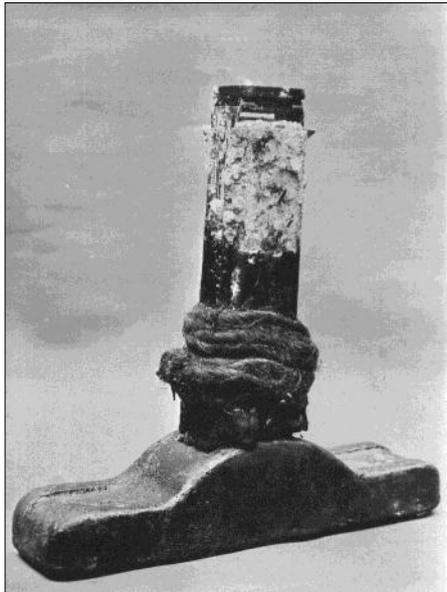
A Griffiths-Bedell stud, probably one removed from Bow Depot in 1939 at the time it was being converted for trolleybuses.

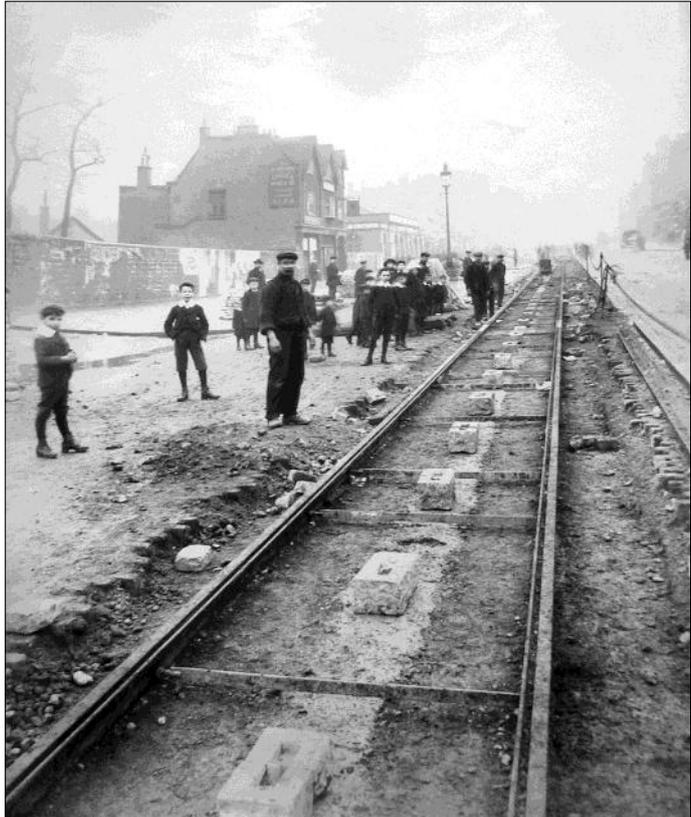
Track with granite blocks ready for receiving studs near Mile End Station

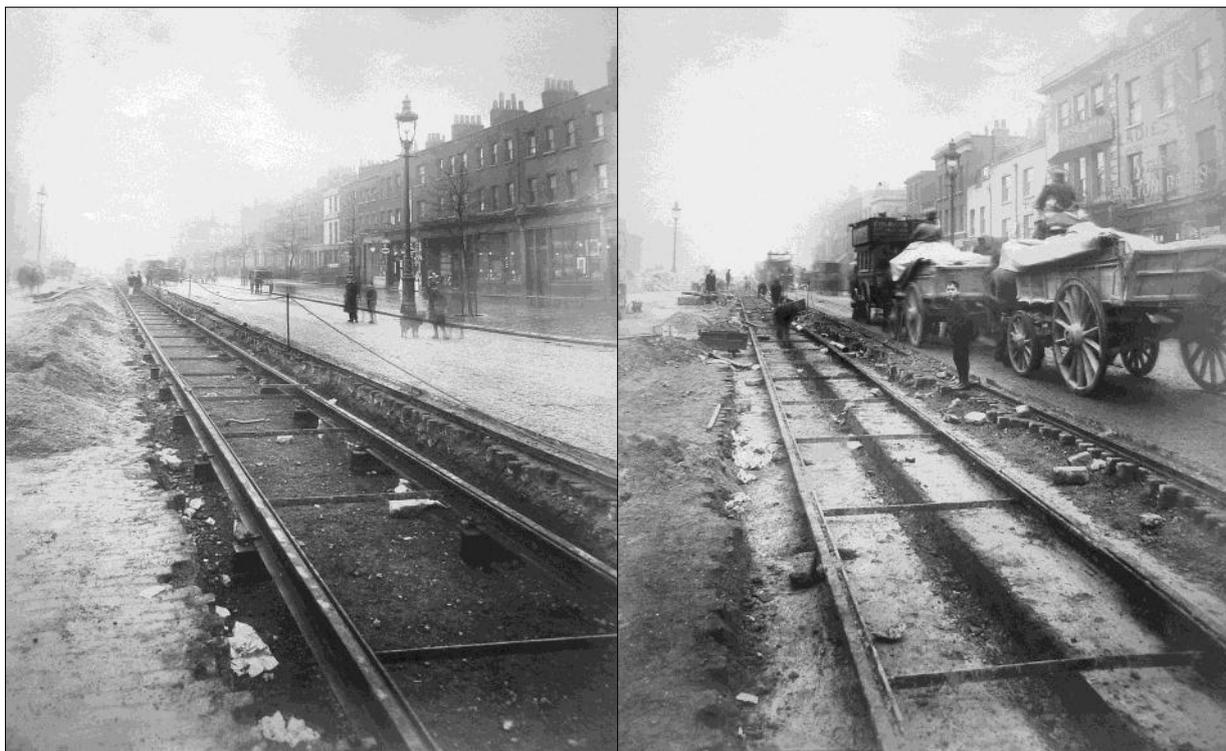
Rails in position in the Mile End Road opposite the Paragon, (*left*) and track ready to receive conduit pipe opposite the Anchor brewery. (*right*)

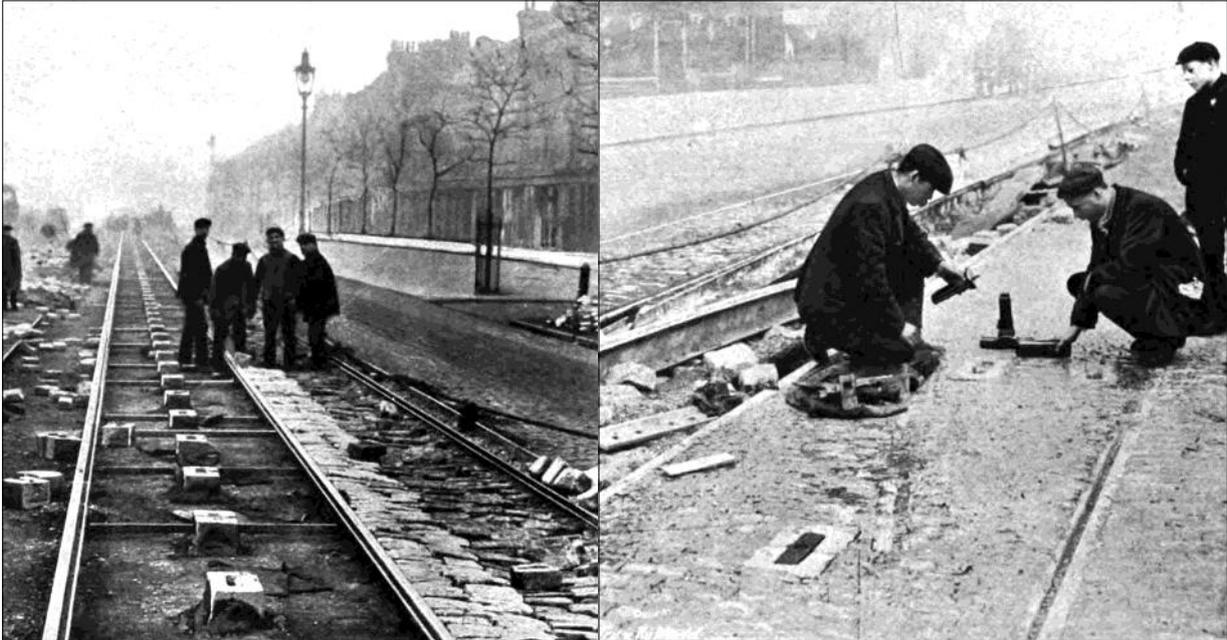
In the Mile End Road with the granite boxes ready to receive studs, (*left*) and with the road surface made up, the studs are actually being. (*right*)
